**Flood Control Project Maintenance
Levee Inspections**

Maintenance Issue Types Only, Levee Inspection Report By Mile - Fall 2016

Reclamation District No. 0369 Libby McNeil

Waterway	Bank	Unit Miles	Inspection Start/End	Inspector
Unit No. 01 Sacramento River	Left	0.78	09/21/2016 09/21/2016	Herman Phillips

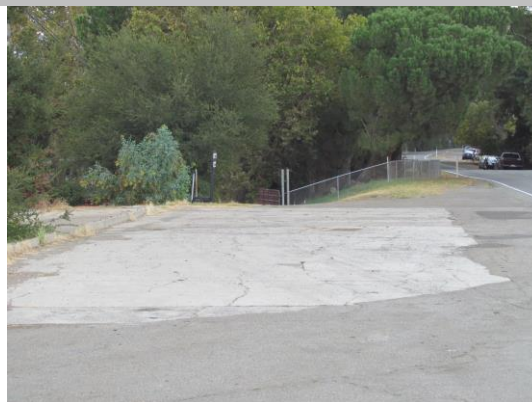
Photo 1 of 1 : FA_2016_RD0369_207_10_20160921_00021.jpg

LM Start	0.02	Rating **	A	Issue No.	10
LM End	0.20	Issue Type +	Ma	Location *	LS
Category	Earthen Levee			GPS Latitude/Longitude	
				Start	End
Item	Vegetation			38.258585 °	38.256932 °
				-121.517593 °	-121.515030 °
DWR ID	DWR_RD0369_01_f_2016_10				
Comment Code					
V1 : Control annual grass and weeds on the levee slopes and easements.					
Inspector Comment					
No unwanted vegetation landside from levee mile 0.02-0.20.

Looking downstream from levee mile 0.02-0.20.

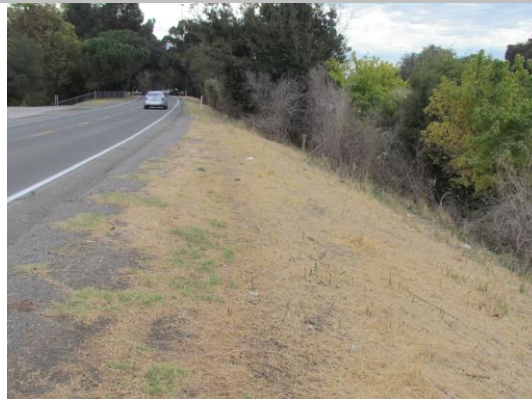
Photo 1 of 1 : FA_2016_RD0369_207_11_20160921_00022.jpg

LM Start	0.02	Rating **	A	Issue No.	11
LM End	0.78	Issue Type +	Ma	Location *	WS
Category	Earthen Levee			GPS Latitude/Longitude	
				Start	End
Item	Vegetation			38.258585 °	38.249743 °
				-121.517593 °	-121.509878 °
DWR ID	DWR_RD0369_01_f_2016_11				
Comment Code					
V1 : Control annual grass and weeds on the levee slopes and easements.					
Inspector Comment					
No unwanted vegetation from levee mile 0.02-0.78 landside slope.

Looking downstream from levee mile 0.02-0.78 waterside levee slope
RD 369.

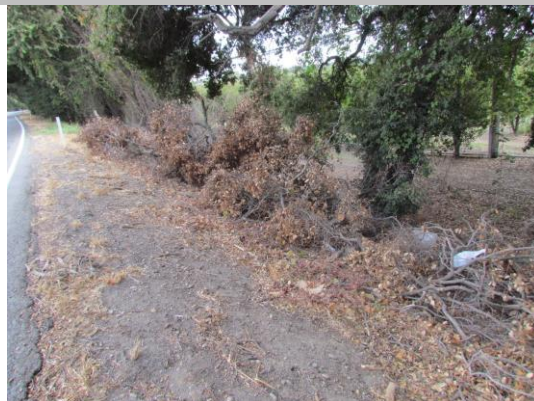
Photo 1 of 1 : FA_2016_RD0369_207_14_20160921_00025.jpg

LM Start	0.50	Rating **	U	Issue No.	14
LM End	0.50	Issue Type +	Ma	Location *	LS
Category	Earthen Levee			GPS Latitude/Longitude	
				Start	End
Item	Encroachments			38.253468 °	38.253468 °
				-121.511692 °	-121.511692 °
DWR ID	DWR_RD0369_01_s_2016_14				
Comment Code					
TR : Tree or limb					
Inspector Comment					
These tree limbs were placed here by the County Fire Department. The storm caused the limbs to break and block traffic. This brush was causing a safety hazard to highway traffic. The County Fire Dept. cut the limbs up and drug them off the HWY. The District must remove the unwanted brush pile from the levee section.

Cut up dead tree limbs remain on the landside levee shoulder and slope since last December.

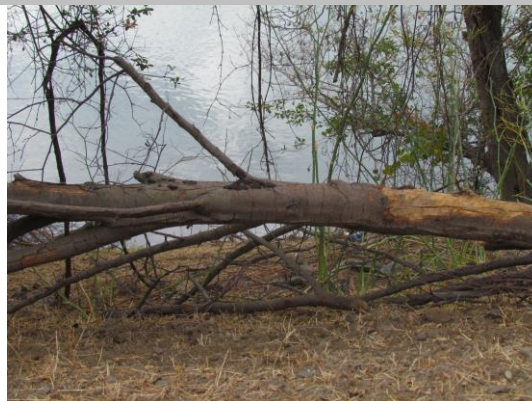
Photo 1 of 1 : FA_2016_RD0369_207_16_20160921_00024.jpg

LM Start	0.53	Rating **	M	Issue No.	16
LM End	0.53	Issue Type +	Ma	Location *	WS
Category	Earthen Levee			GPS Latitude/Longitude	
				Start	End
Item	Encroachments			38.253095 °	38.253095 °
				-121.511387 °	-121.511387 °
DWR ID	DWR_RD0369_01_s _ 2016_16				
Comment Code					
TR : Tree or limb					
Inspector Comment					
Cut up and remove the dead tree from the waterside slope. This tree was reported during spring inspection 2016.

RD 369 Levee mile 0.53 waterside levee slope.
